View of the North elevation of the 332 Congress Street building along the rear alleyway.

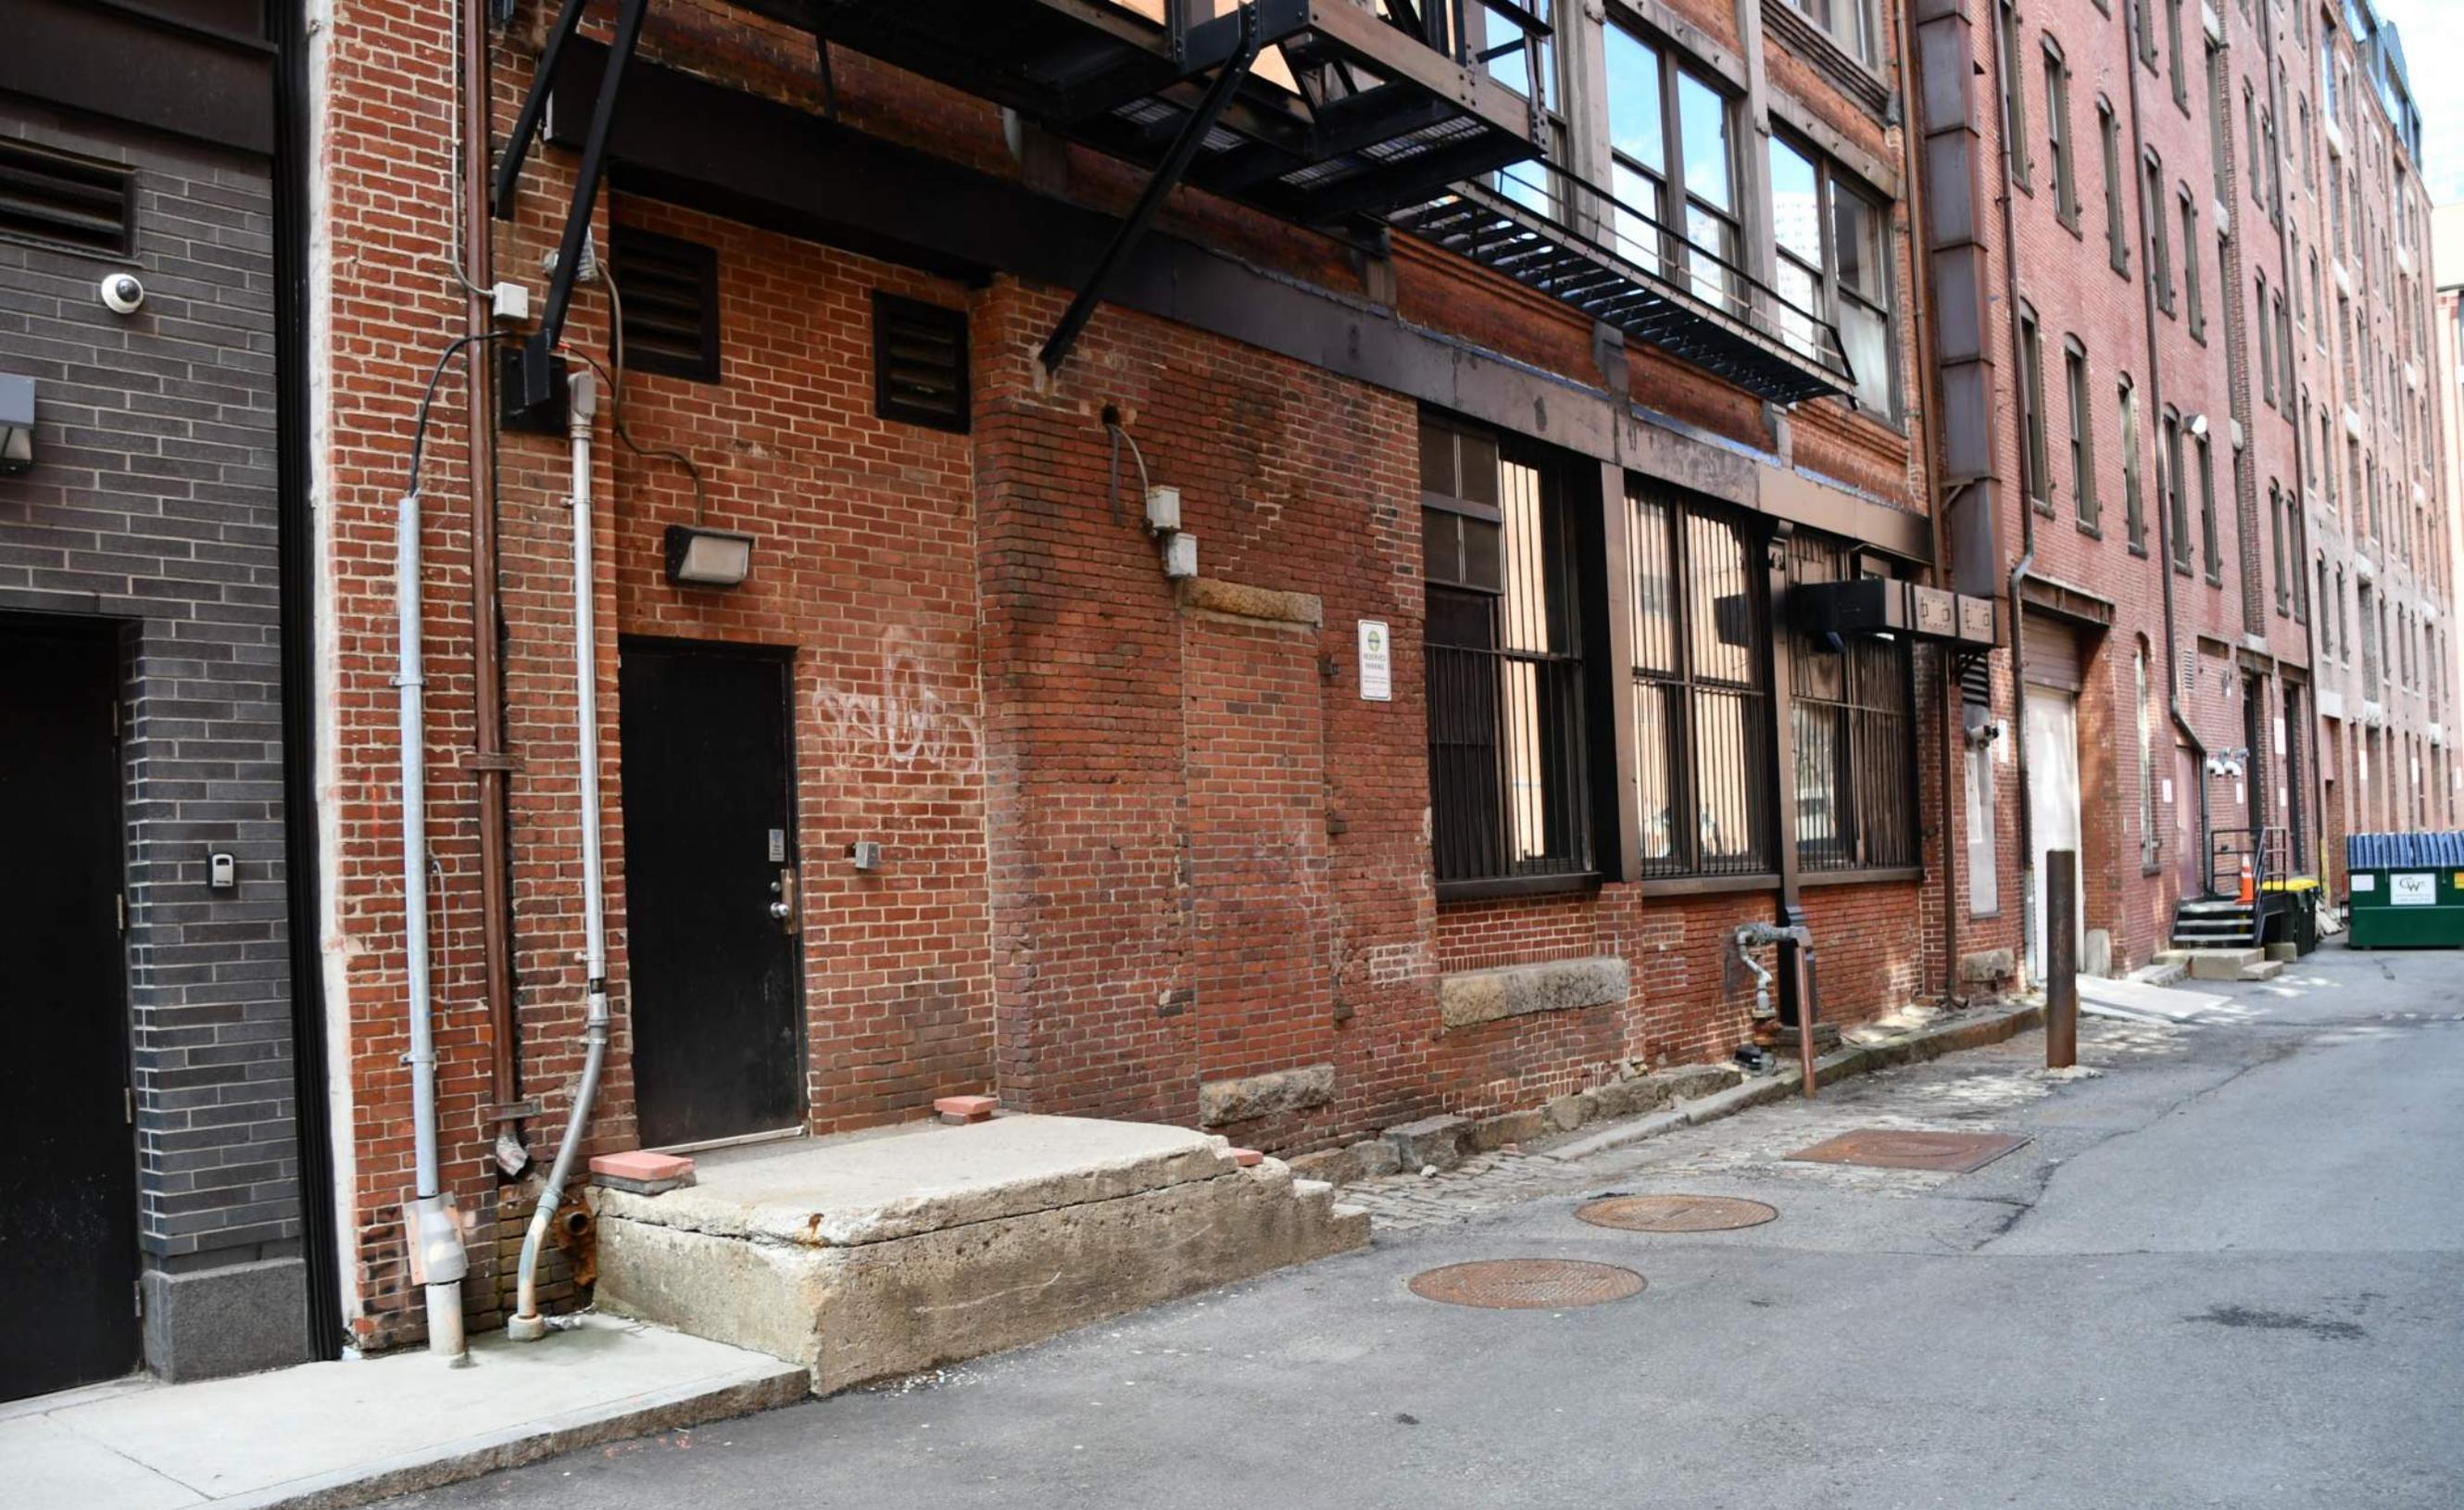
View of the lower portion of the North elevation.

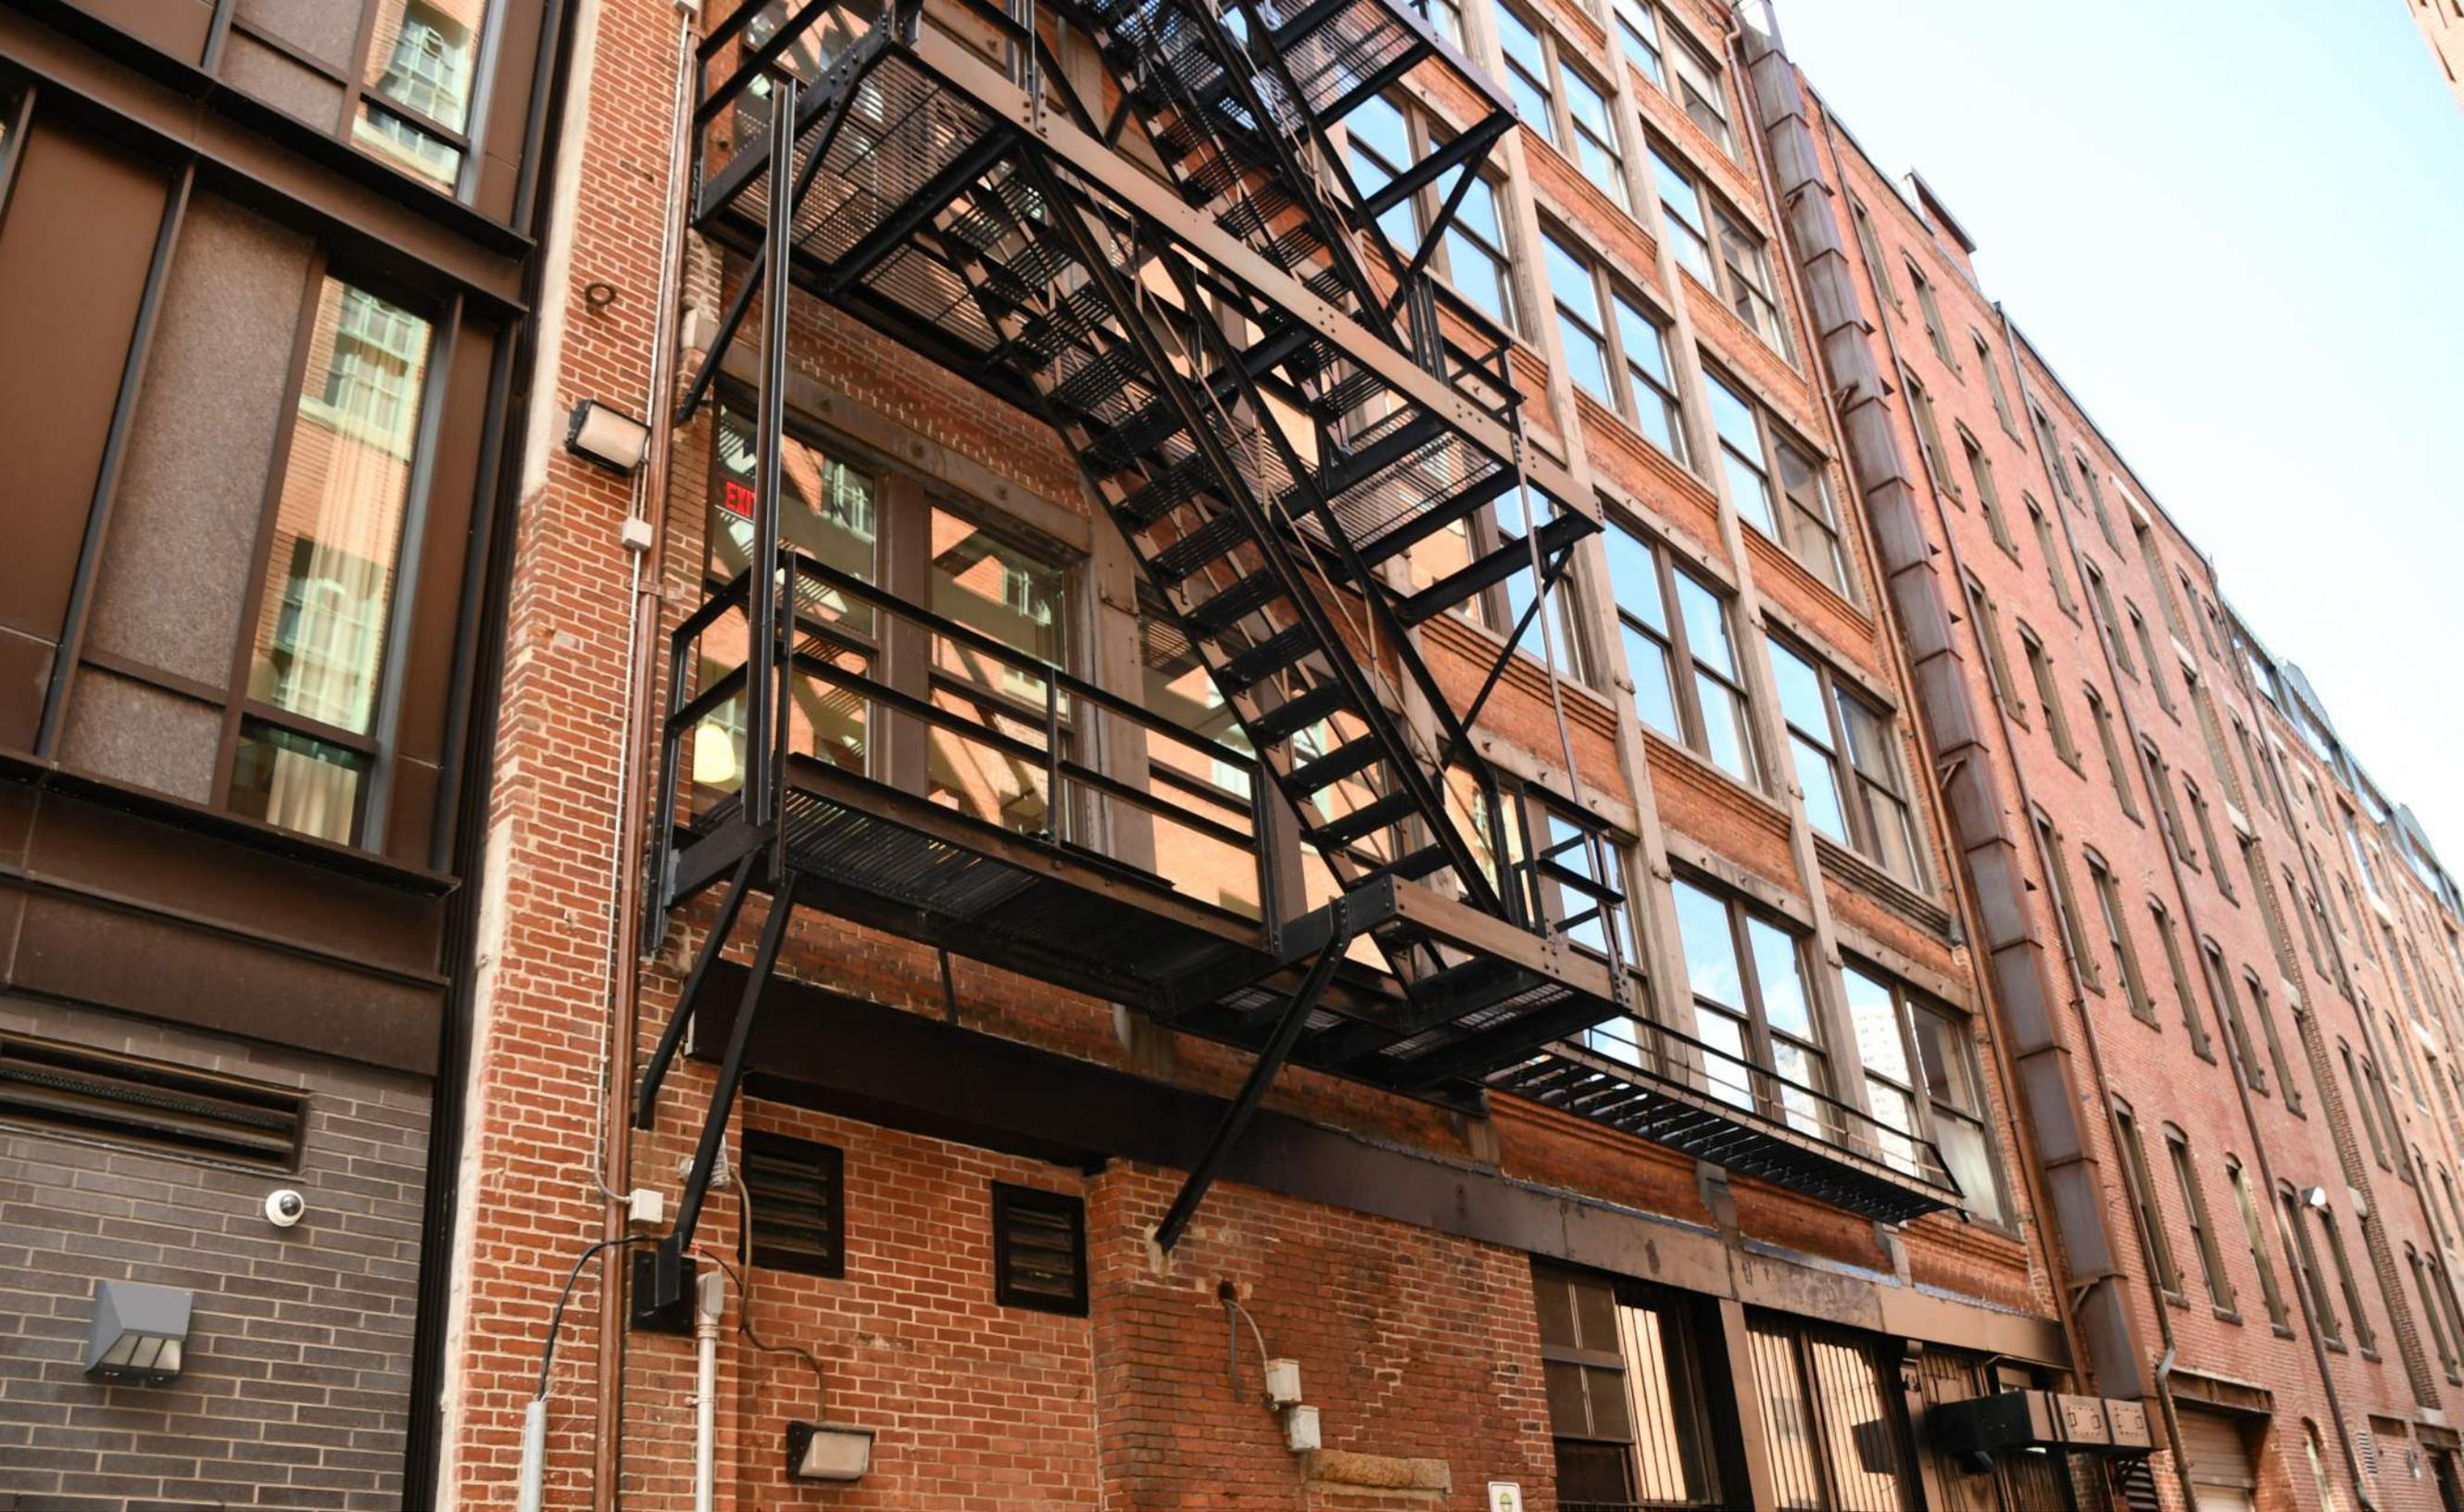
View of the middle portion of the North elevation.

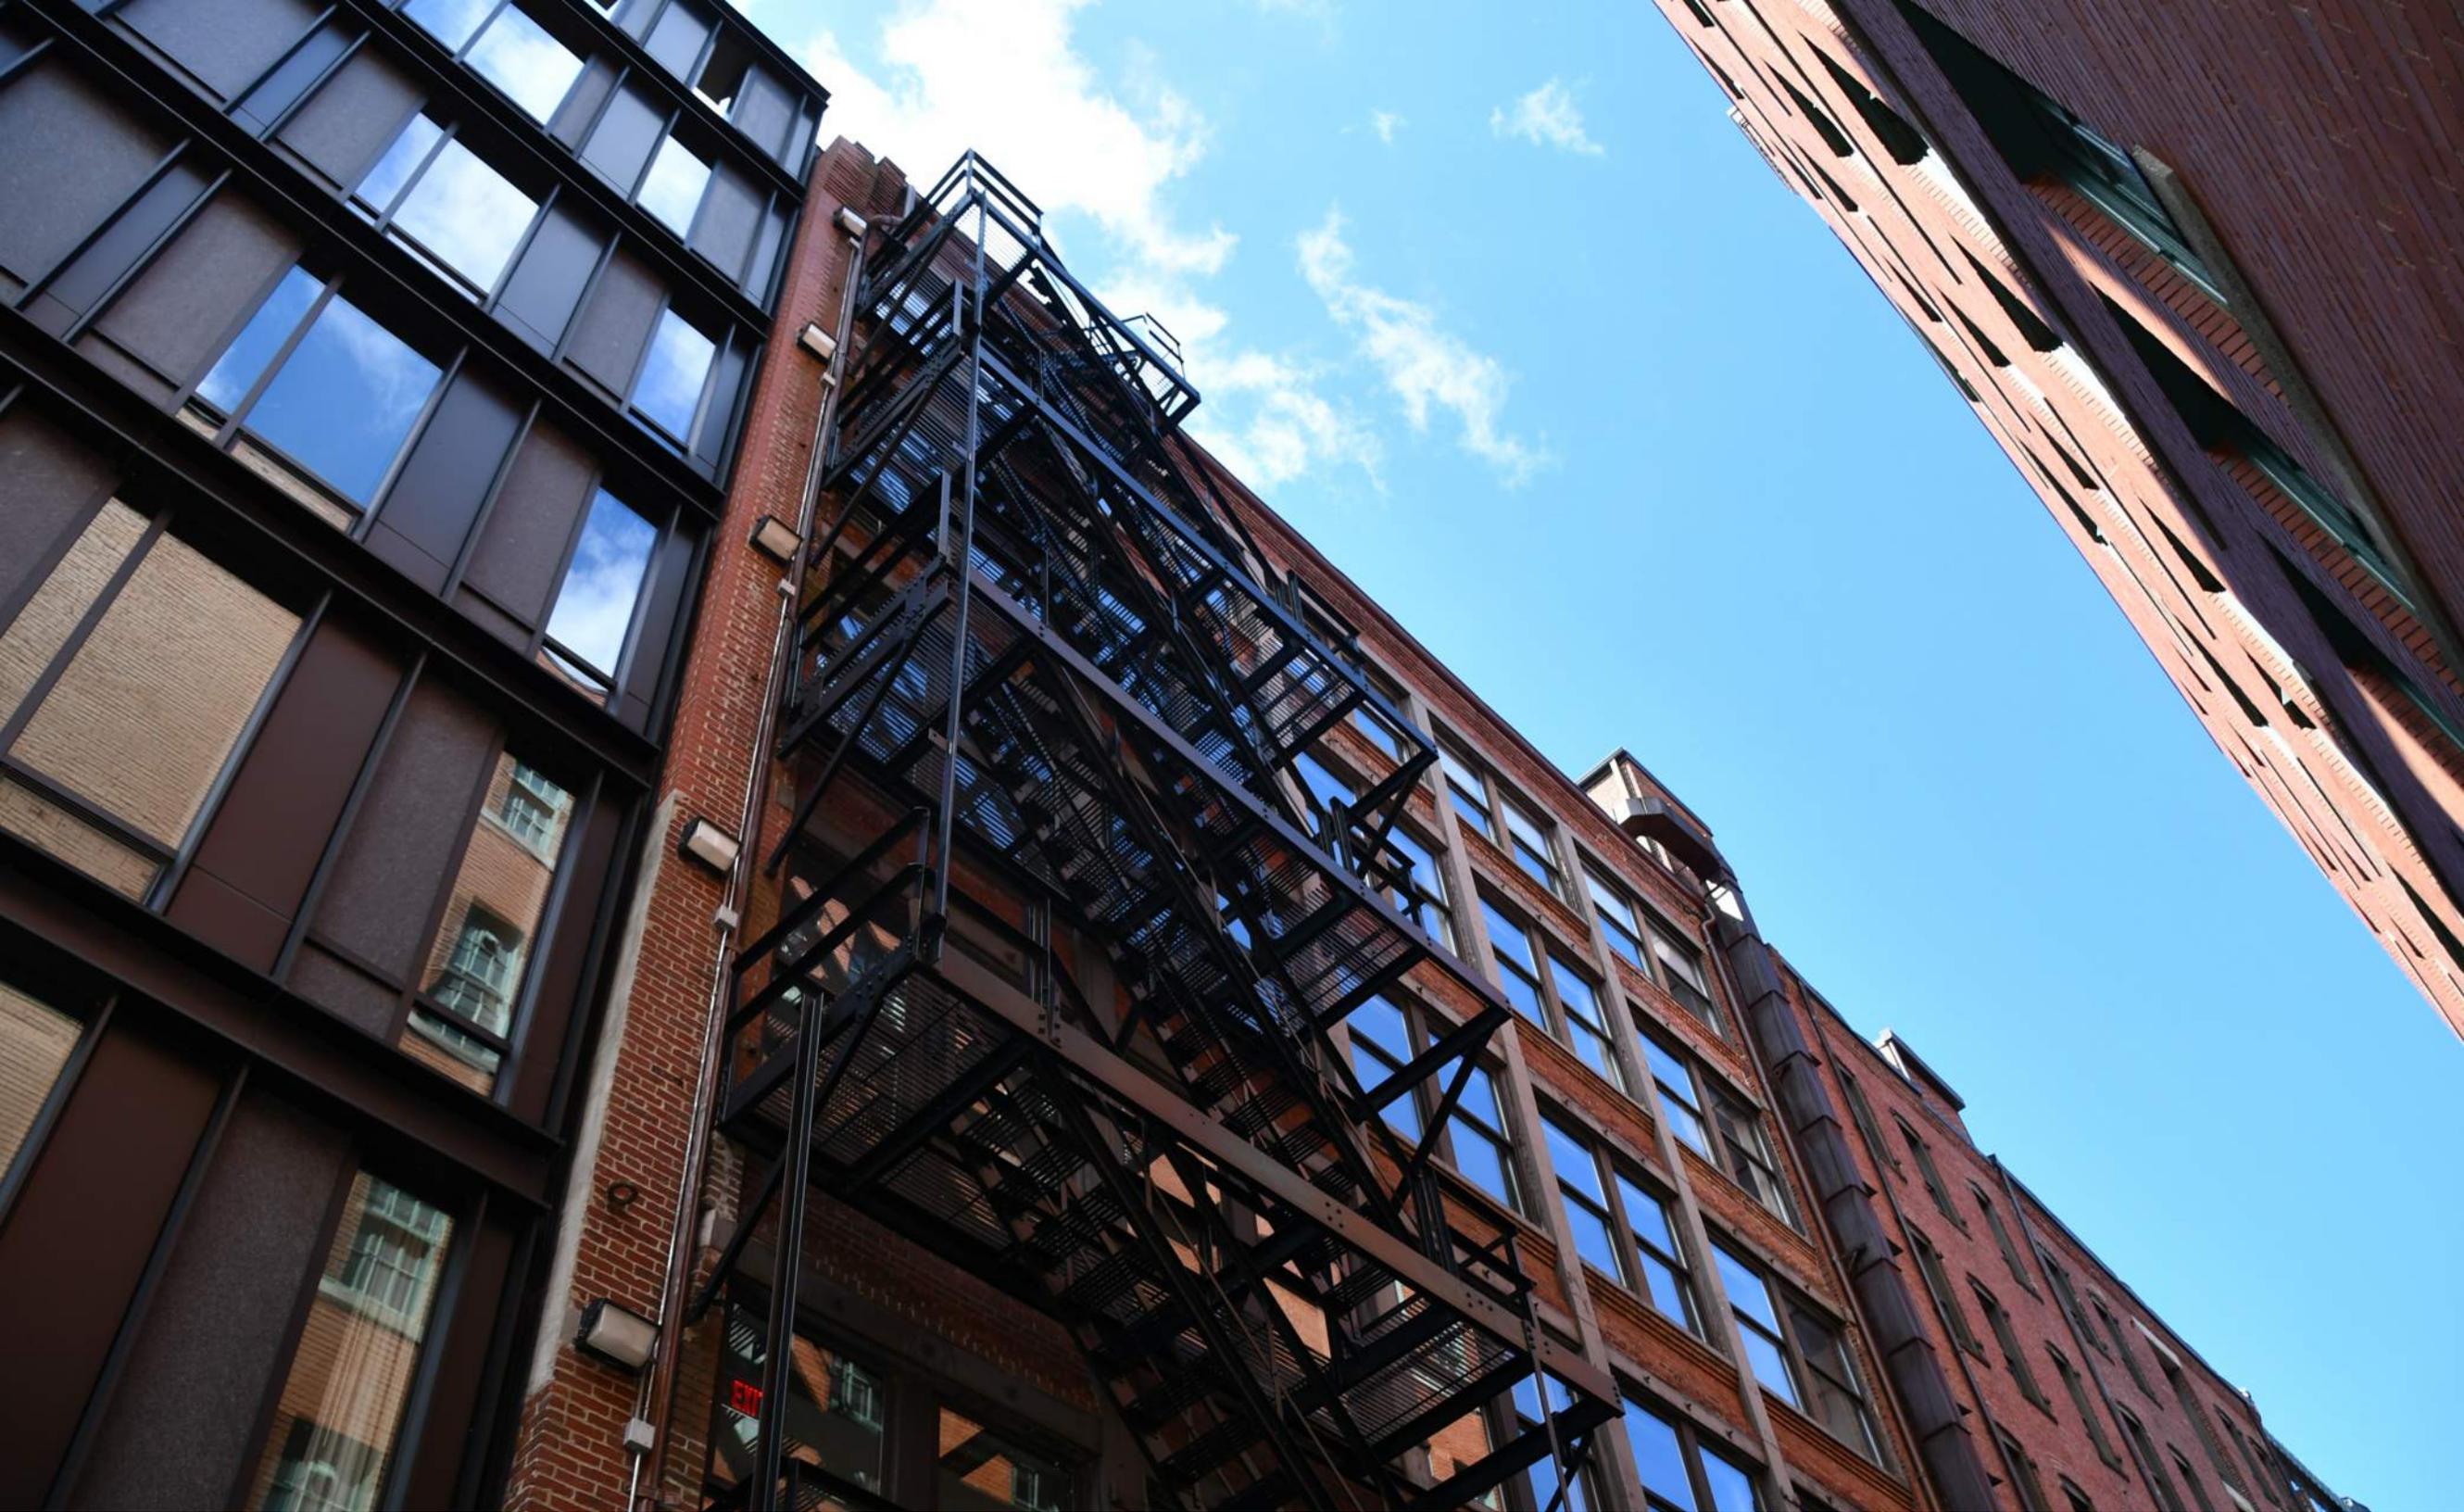
View of the upper portion of the North elevation.

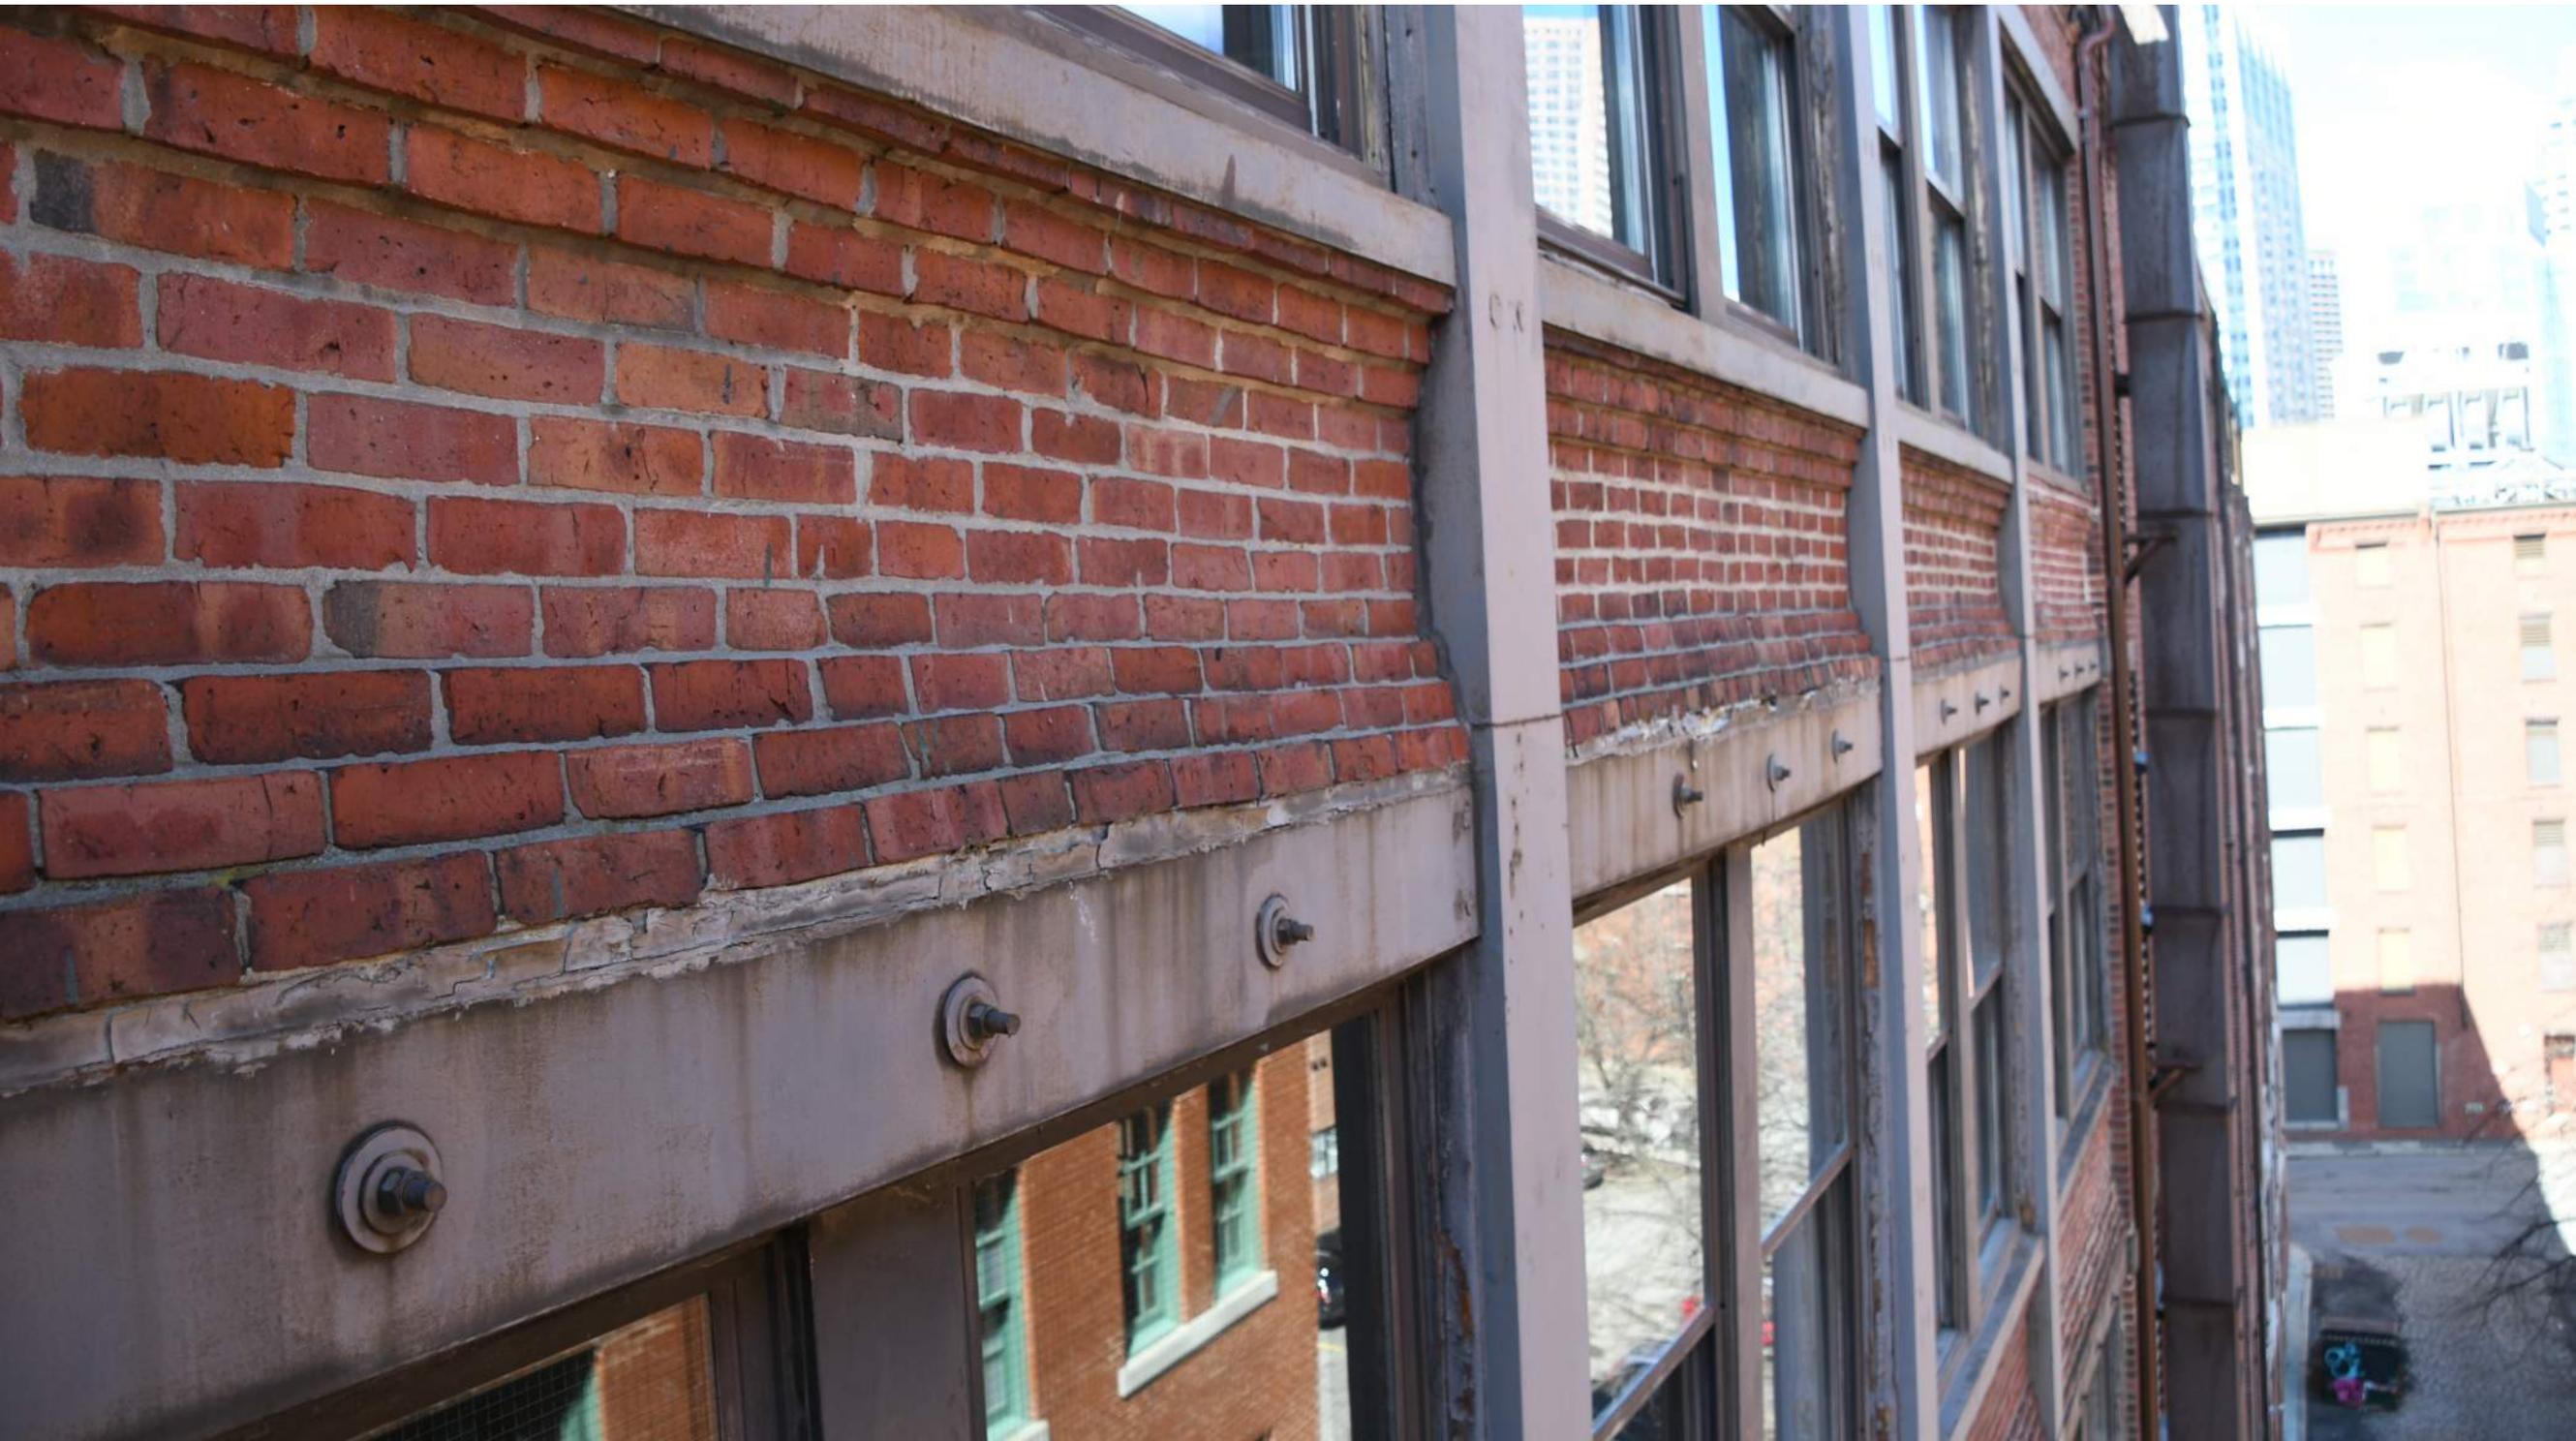
View of typical displaced brick masonry atop cast iron channels at spandrel areas between window openings. The channels and multiple wythes of the first three courses of brick masonry above will be removed to install new channels, install new waterproofing and brick masonry backup, install new through-wall flashings, and install new brick masonry.

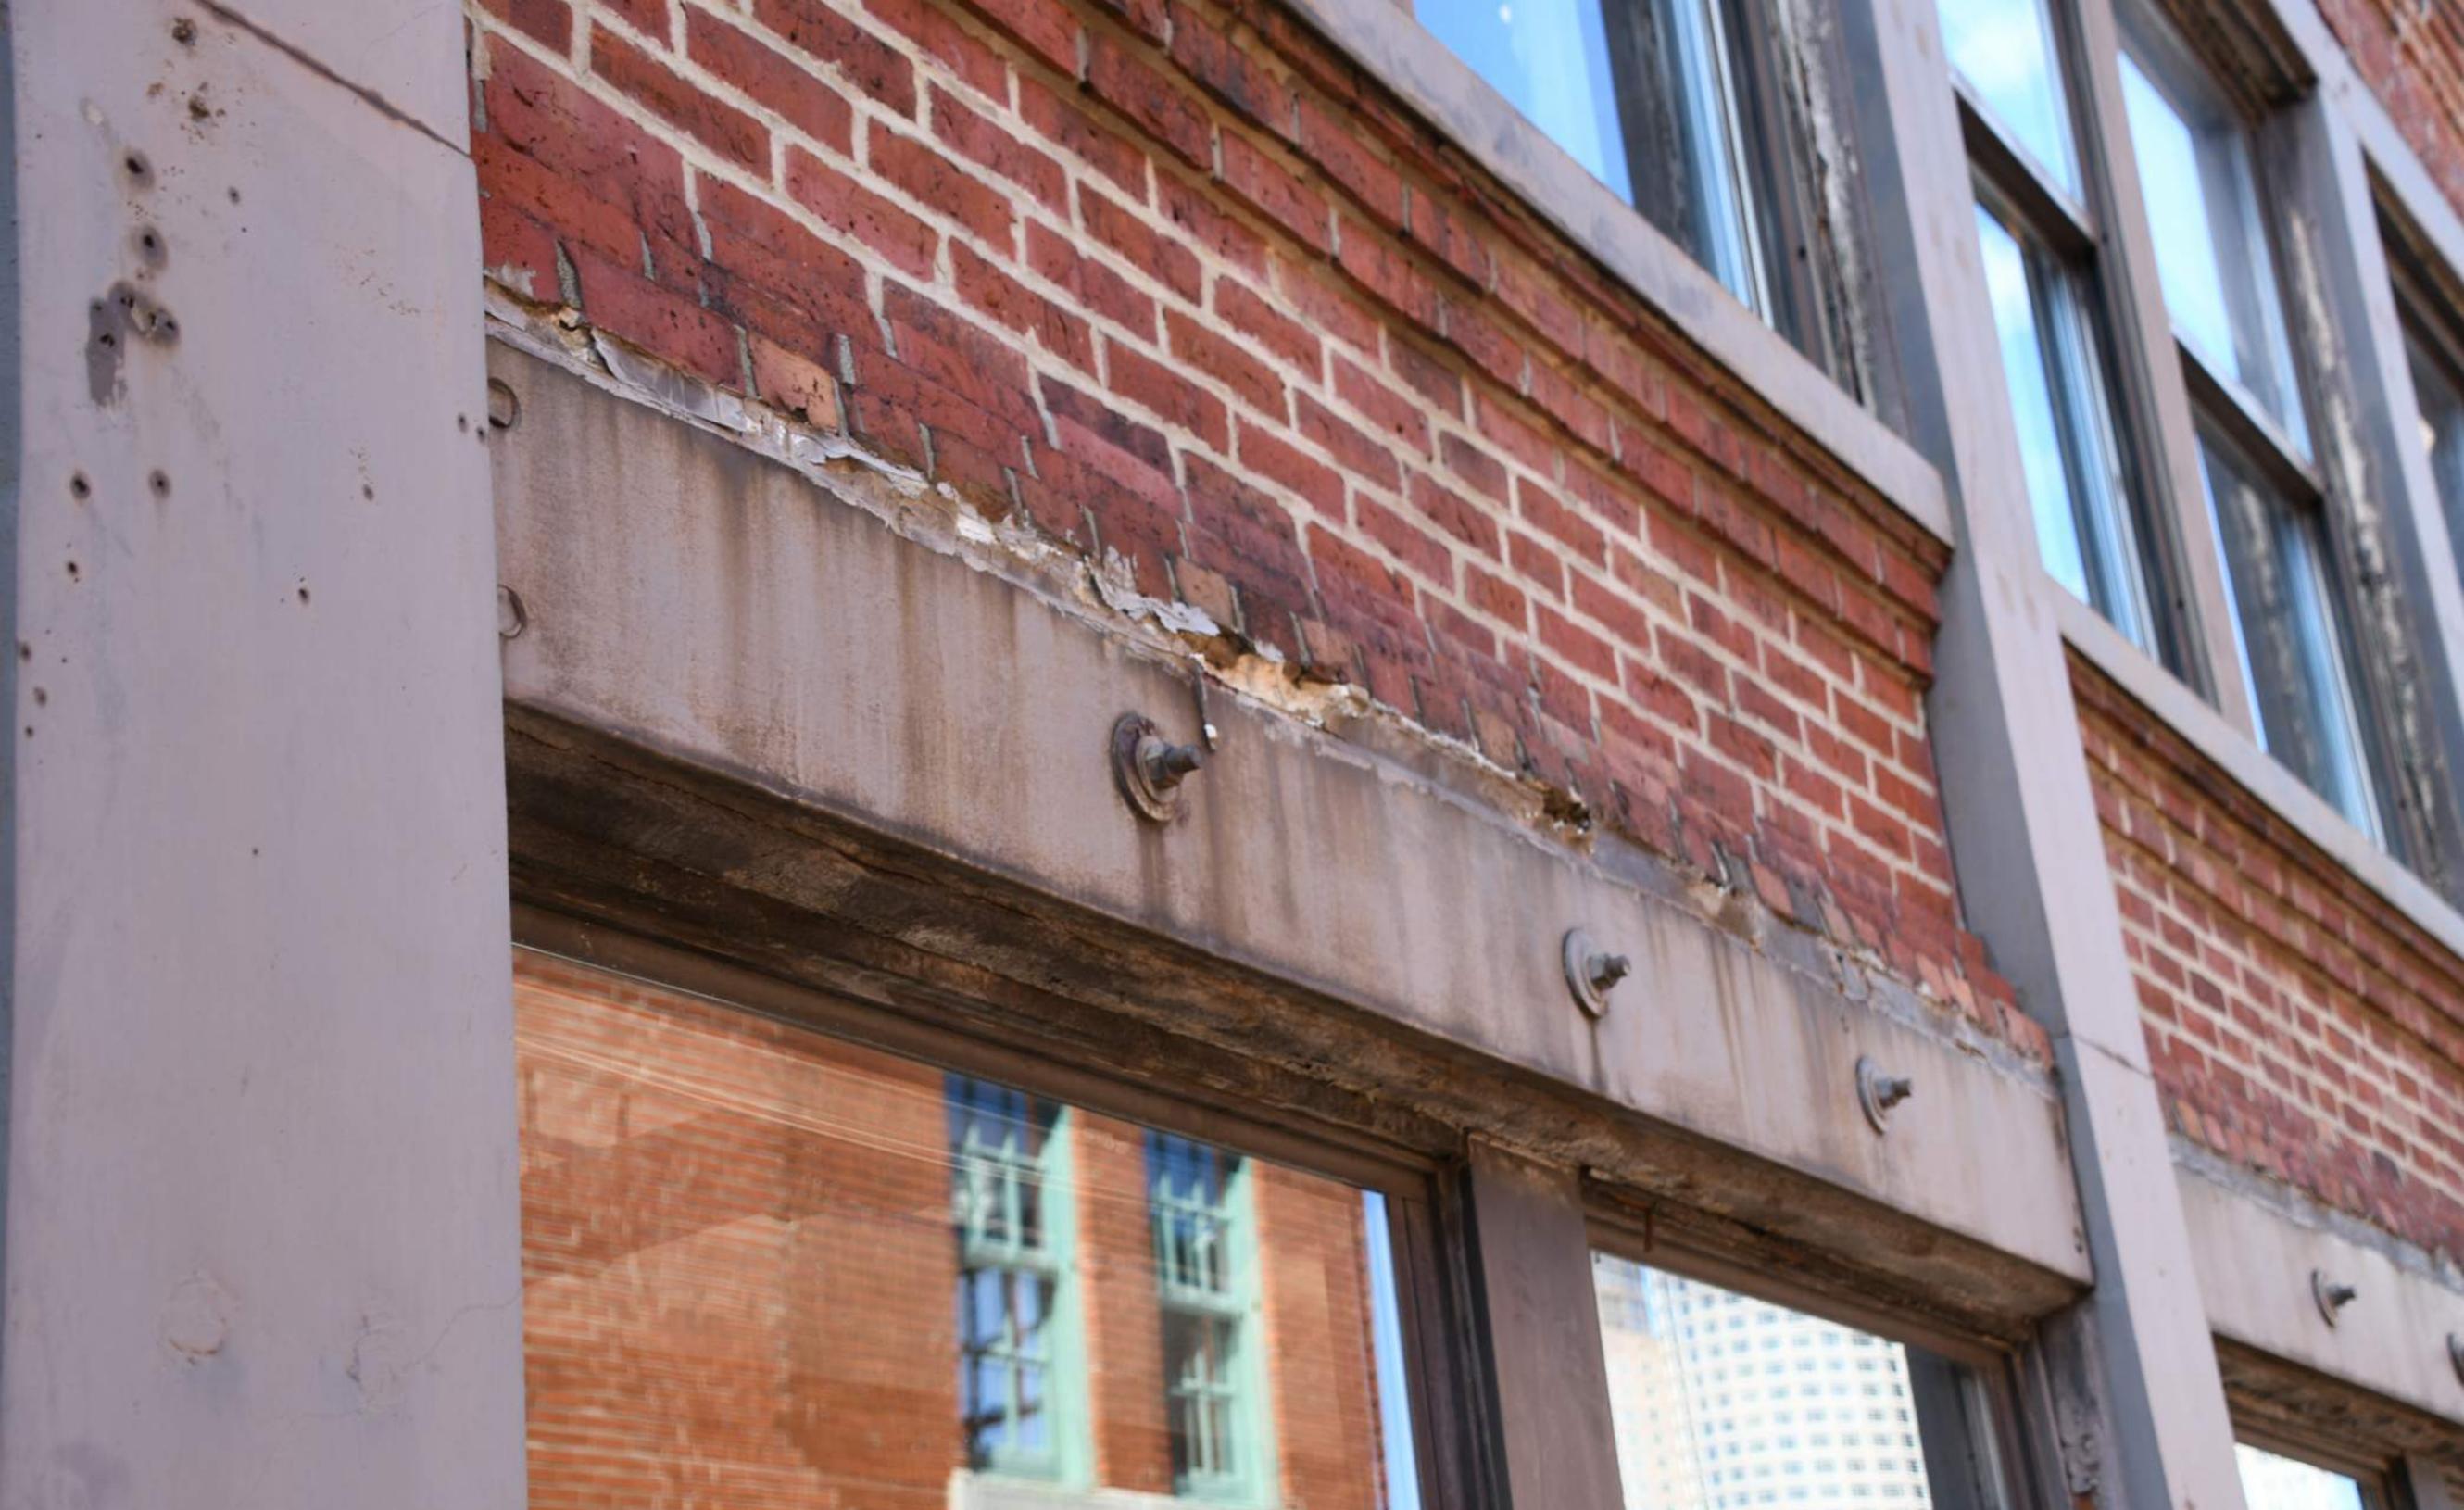
Additional view of a typical spandrel area.

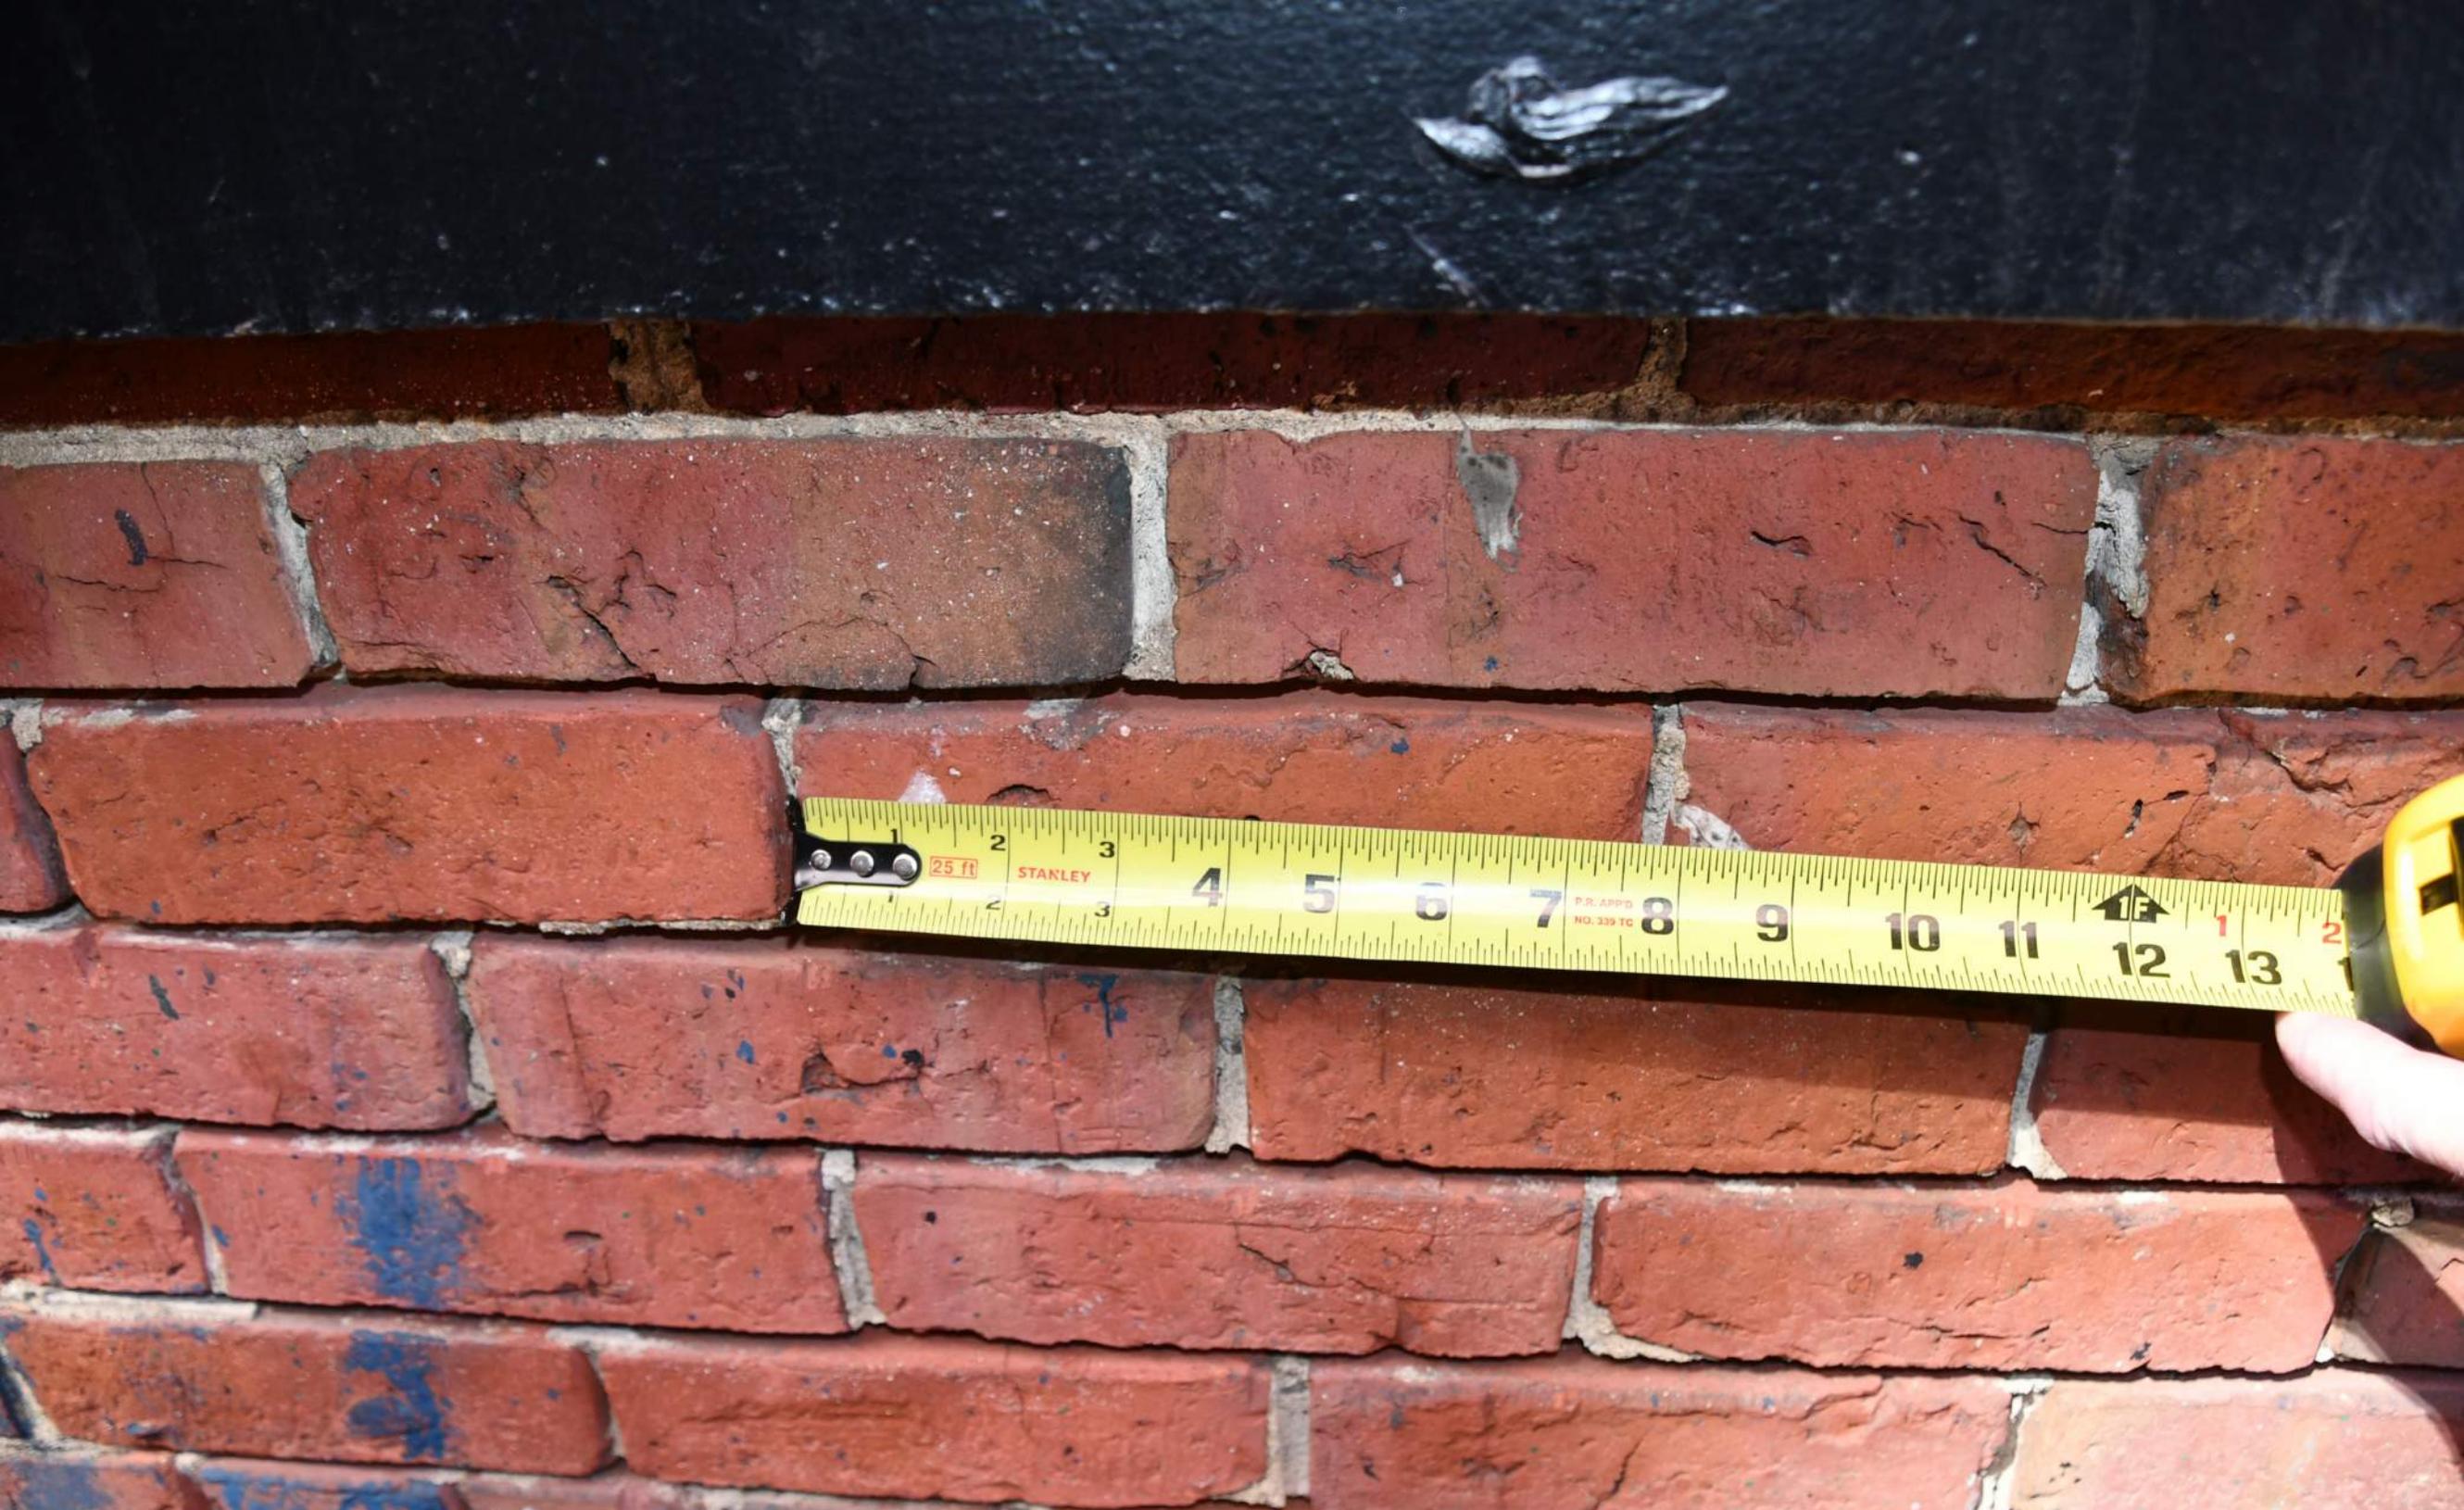
View of typical deteriorated brick masonry mortar joints that will be repointed to match the existing mortar in color, composition, and tooling.
